Overview P&A operations Coal Exploration Bore R2315

Green Swamp Road, 15km SW of Chinchilla, drilled in 1981

The University of Queensland, School of Chemical Engineering

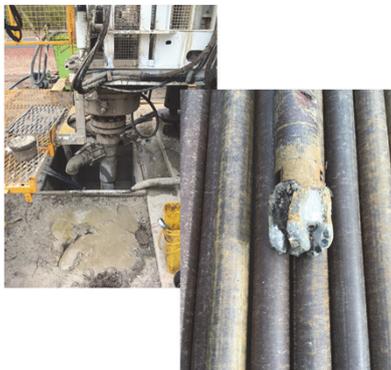
Fig 1: A 4 3/4" BHA was made up and the used to ream down the hole to 113.7m GL.

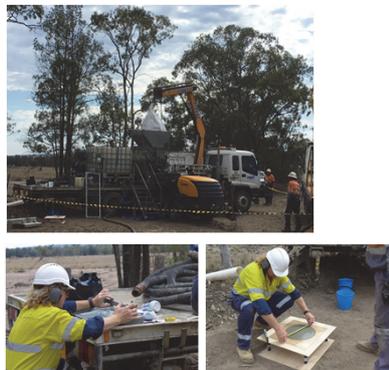
Fig 2: 205l of 1.94SG grout was mixed and pumped in hole. After 3h WOC the top of grout was tagged at 94.7m GL.

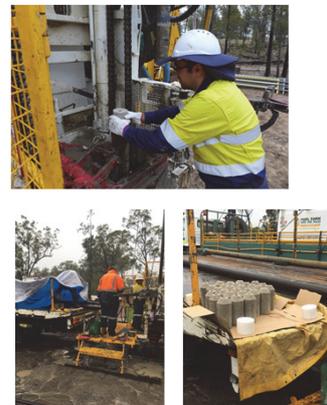
Fig 3: 467 bentonite plugs were placed successfully on top of the grout to reach final top of plug at 6m GL as per program.
